Specific slope stability study of Aomar region— characterization and proposal of reinforcement measures

Tawfiq Boufrina

University of Blida-1 Saad Dahleb, Blida, Algeria, tawfiq.boufrina@univ-blida.dz

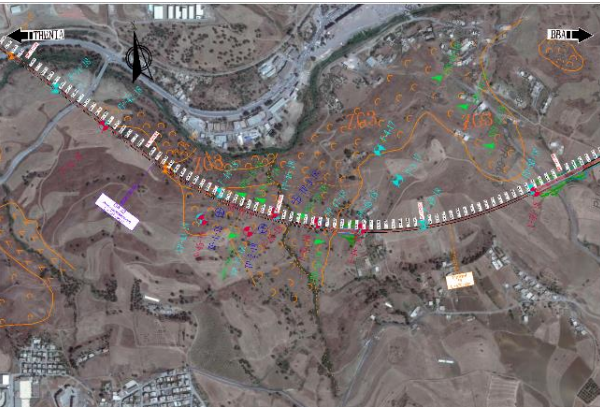
Figure 2. Railway line crossing the sliding area between PK36+300 and PK37+900

The new line crosses the slopes of the "Aomar" region between the kilometric points PK36 and PK46 (Fig. 2) and continues along a hilly topography with slopes of more than 15%. This area is affected by many instabilities areas which generally follow a parallel movement to the direction of the slope.

We were interested in this work to study the most important sliding area located between PK36+300 and PK37+900 from many aspects mainly geomorphology, geology, hydrogeology and geotechnics.

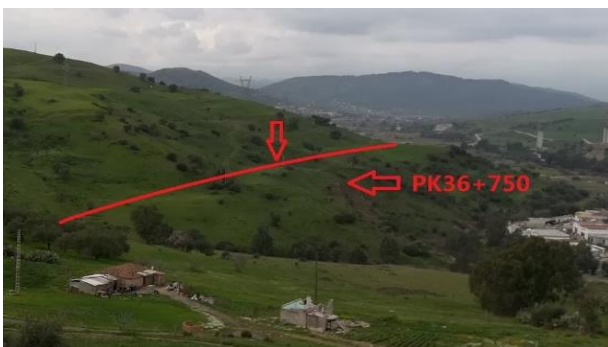
Figure 3. Topography between PK36+600 and PK37+050: View of the foot of the slope, with the sandstone bench

This clayey marl area has undergone landslides in three different directions, it is characterized by significant slopes exceeding 40%. Several significant landslide areas have been identified.

Detailed geological mapping of the sliding area (Fig. 3) has made it possible to identify the area in motion, to properly locate and delimit unstable parts, as well as the geological, hydrogeological and morphological environment in which they have evolved.

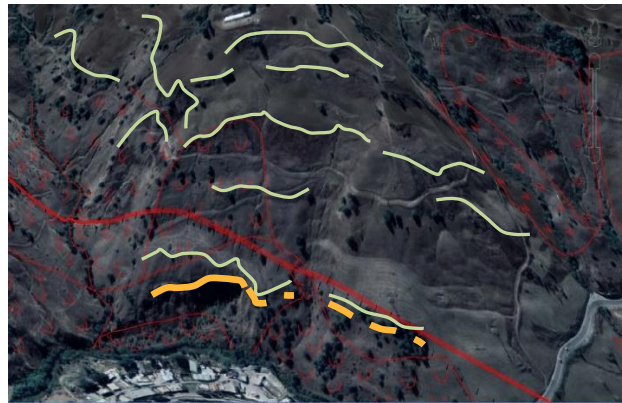
Figure 4. 3D satellite image from PK 36+300 to PK 37+150

Between PK 36 + 300 and PK 36 + 600 (Fig. 4), the terrain is relatively flat, then the natural slopes of the terrain gradually increase, reaching 20° in some places. The section between PK36 + 700 and PK36 + 800 is characterized by the presence of a cliff of approximately 30 meters high, corresponding to a sandstone bank (continuous orange lines - visible bench, discontinuous line - probable bench).

From a morphological point of view, the existence of this sandstone bench makes it possible to dissociate the upstream and downstream areas. The upstream area affected by the landslides are limited in their lower part by this stable slope. This makes it possible to assess the depths of the fracture surface at about 10 m at the level of the bridge foundation. And also to consider that there cannot be a deeper surface, which would extend from the top of the slope to the bank of the wadi (rejected hypothesis).

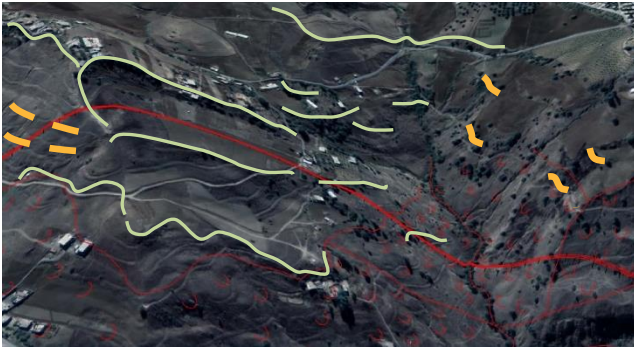
Figure 5. 3D Satellite image between PK 37+150 and PK 37+900

From PK 37+150 (talweg) to PK 37+500 (Fig. 5), the slope is generally regular, with slight huming. To the right of the railway line, begins a very flat and sloping large surface (this point corresponds to the entry of the TU09).

From PK37+500 to PK37+700, there is a large flat surface, surrounded upstream by an old tearing pattern, which would suggest a sliding crown, suggesting that the flat surface would correspond to the upper part of a very large sliding body. However, this morphological interpretation is not compatible with the flatness and inclination of the surface.

Beyond the slope break at PK 37+700, we descend to the road at PK 37+900, exit of the tunnel TU09. This slope is marked by a direct erosion morphology, which indicates the presence of sandstone marl. These benches extend laterally quite far, indicating that they have a regular dip.

This observation leads to the conclusion that the previous large flat surface is in fact a stratigraphic structural surface. The crowning all around would then represent the scar of an old landslide and total flattening of the entire rock cover. Such a slide in sandstone marl,

with clayey marl intercalations, is only possible in an earthquake situation. If this hypothesis is correct, the downstream slope would correspond to the accumulation of residues from this large, abrupt rock slide. It turns out that in this area, there are many sandstone blocks scattered on the slope, which support this hypothesis.

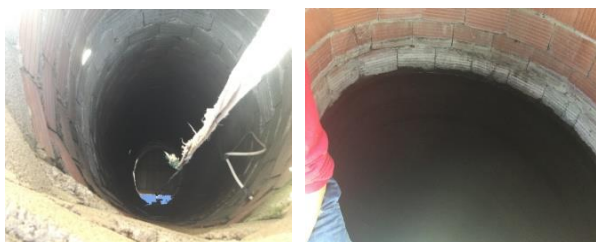
Figure 7. Several wells located in the sliding zone

Groundwater is omnipresent in this sliding area (fig. 11). The groundwater level recorded in the piezometers is located in the weathered clayey marl and varies from 1.0 to 9.50 m from ground level.

It is important to note the presence of several wells along this section with a practically water level on the surface. The small dam located upstream (100m in vertical drop upstream) of the line could be part of the source of supply for these wells, especially in dry periods.

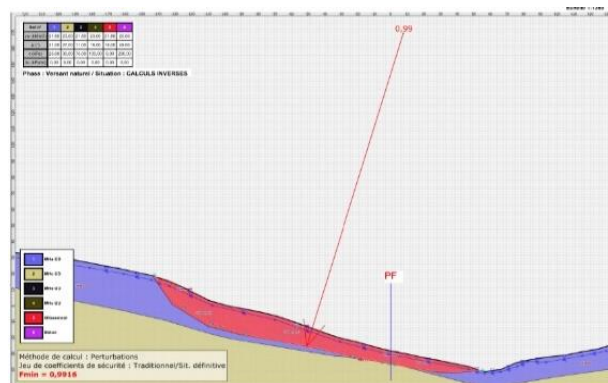
Figure 12. Back analysis section 2-2' at PK36+800 (Pier 35)

Back analysis is carried out using the french software TALREN by the limit equilibrium calculation method according to the simplified Bishop formulation and/or the method of perturbations, Fig. 12 shows the results obtained from back analysis performed on one of the four selected critical sections.
