Several cases of backward erosion/liquefaction piping from Hungary

BSTRACT: Some cases of backward erosion/liquefaction piping are described. These distinguish between usual sand boils and the ‘fast’ piping, the - possibly dynamic liquefaction induced – breach. The latter happens in a matter of minutes, whereas in the former emergency response measures can be effective.

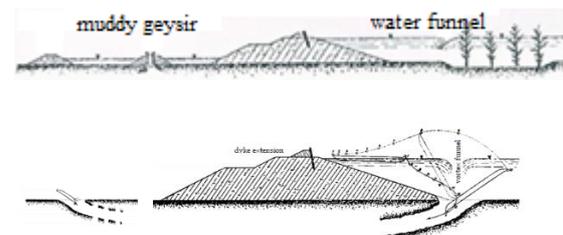
Figure 1. Illustration of the boat diving to the pipe in 1926, (a) condition some minutes before breach, (b) the path of the boat, which ended on the safed side at around the first sand-boil spot.

Breach day: The breach happened as follows within some minutes. A mud geyser appeared at the spot of the first sand boil. Seeing this, the chief engineer immediately ran up to the embankment crest and glanced at a funnel about 30 m from there, which was constantly approaching the embankment (Fig. 6). He immediately set the boat perpendicular to the embankment and carried earth sacks in the tail of the boat to sink (Fig. 6). During this time, there were again 2-3 volcanic muddy water eruptions, and these were already stronger than the first.

When the vortex water funnel - constantly approaching the embankment - was 15-20 meters away from the crest, the boat suddenly began to tilt, his nose staring at the sky and made a path marked with numbers while diving under the water. The boat appeared on the other side of the levee. Subsequently, the crest began to crack, the embankment settled to a length of 8 to 10 meters, the water began to flow into the saved area, and the dam breach soon widened to 80 to 100m. The depth of the washout was 24 meters below the flood level

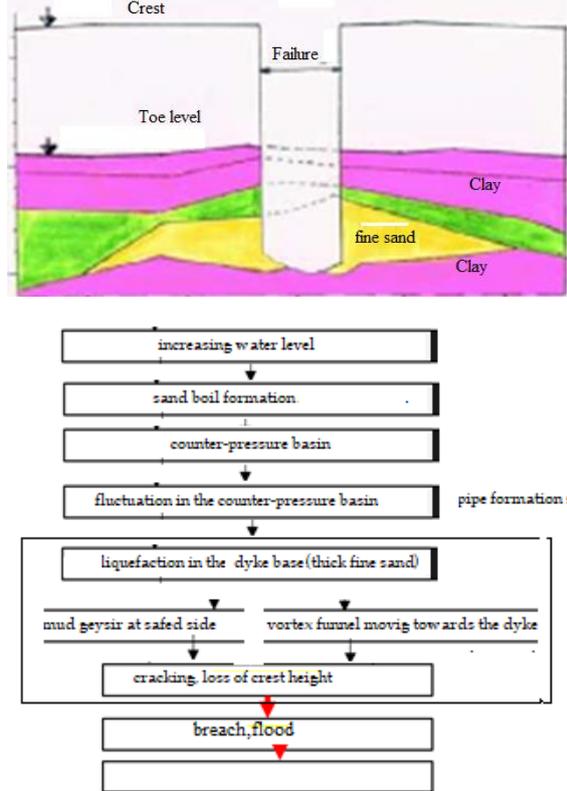
Figure 3. Layering leading to fast piping and possible fast piping scenario. It is a question if static liquefaction, dynamic liquefaction may occur or both.

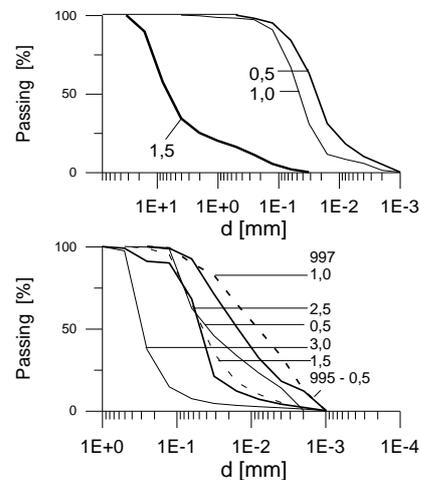
Figure 5. Grading curves for the (a) Dunakiliti soils and (b) the Dunafalva soils. (c) and (d) Layers leading to sandboils.

Soil layers below the dyke were explored at two piping sites: at Dunakiliti and Dunafalva Figure 3-27. The Danube valley has a thick silty cover. A 0.5 m thick silt layer and a 0.5 m thick Mo layer were found above the sandy gravel layer at Dunakiliti (Mo is a soil category between silt and sand in earlier soil classification systems). Mo, silt, Mo and sand layers were found with a thickness of 0.6, 0.9, 1.3, 0.2 m, respectively, above the sandy gravel bad at Dunafalva. The grading curves are shown below.

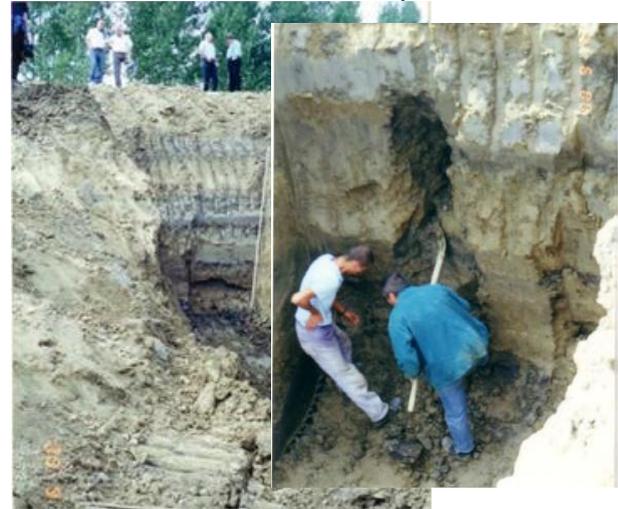
Based on the washout soil, which was more than two cubic meters, a sieve analysis was carried out. The uniformity coefficient of the silty sand was $CU = 2,74$, $d_{80} = 0,11$ mm. The opening of the sand boil could only took place at the beginning of

September. The cut through the levee showed the stratification and the path of the sand boil, which was first deep at the bottom and then it went up the waterside. Figure 3-29. shows the investigation and suggested that the sand boil occurred in a thick silty sand layer, which was covered with arched clay.

Figure 7. Opening of the sand boil

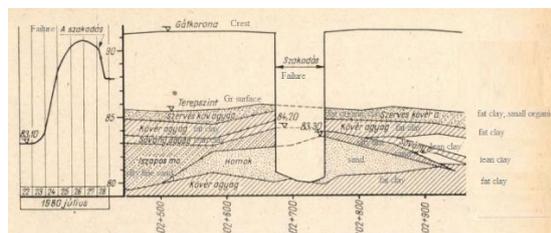
Figure 8. Kettős Körös river, Hosszúfok in 1980, fast piping failure, schematisation of subsurface at failure location.

The dam burst took about 5 minutes. The width of the tear grew rapidly, reaching a final width of 78 m. This was the first dam failure where detailed soil mechanical exploration was made afterwards

The evaluation: the piping mechanism is possibly liquefaction of the extremely loose and thick sand lens at the thickest dimension of the layer. The cause was assumed dynamic effect caused liquefaction. The possible dynamic effect was the tearing off the clay cover layer at the first geyser spot and the sudden displacement of the dyke body due to the increased horizontal load.

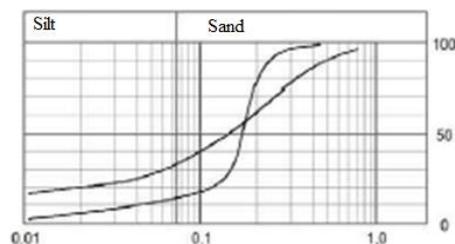
Figure 9. Kettős Körös river, Hosszúfok in 1980, fast piping failure, grading curves, indicating the very loose sand inclusion with $3 < Cu$ and $e \sim 0,8$ (Szepessy, J.(1983)).

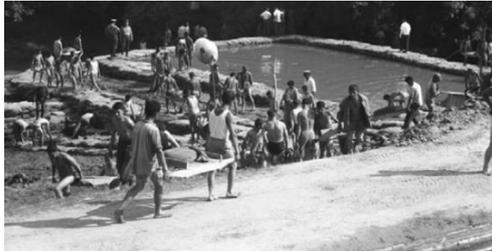
Figure 10. Danube, Margitta Island piping, counter-pressure and diaphragm walls at the waterside, the cause was the vicinity of an old meander, Horváth 2001
