Field investigation on a sinkhole developed in the loose volcanic ground

ABSTRACT: Due to the typhoon on Sept.19, 2016, a large sinkhole occurred in a sweet-potato field, leading to a soil outflow of 1500 m³ to the road nearby through a piping hole. The size of sinkhole was 31m long, 13m wide and 7m deep. The area is covered by the volcanic soil, called Shirasu, which generally has low density and high permeability. Surveys including dynamic cone penetration tests and surface wave surveys were conducted to identify the locations of subsurface cavities, water paths and loosened ground. Very loose Shirasu layer was identified above the impermeable clayey layer at the depth of about 12m. Water paths seemed to form within Shirasu layer and Shirasu was subjected to internal erosion. A relatively stiff layer was also found at a depth of 4m, below which the erosion seemed to be accelerated. Surface wave survey results indicated that water paths, the potential cause of sinkholes, were further extended. Judging from elongated shape of the sinkhole, two or three sinkholes simultaneously or successively occurred above the water paths.

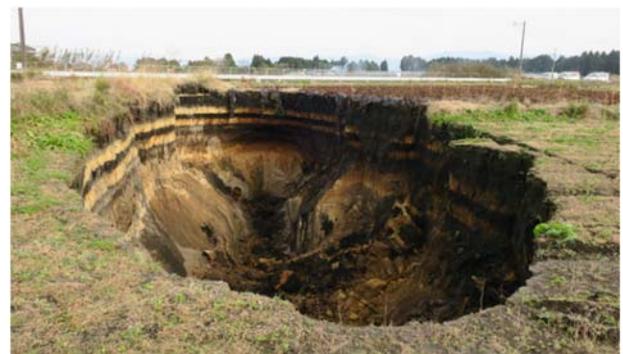
Figure 1. View of the sinkhole

The sinkhole was ellipse shape, with about 31m long, 13m wide, and 7m deep. There was a gap of 2m high in the ground connecting between the bottom of sinkhole and the road running beside it, through which soil seemed to sprung out from the sinkhole. Estimated amount of soil outflow was about 1500m³. Length of the gap in the

A photo of the sinkhole is shown in Fig. 1 and a cross section is schematically shown in Fig. 2. The sinkhole was found after typhoon No.16 had passed on September 19, 2016. The second largest intensity of rainfall, 88mm/h, in Miyazaki prefecture was recorded at around 2AM.

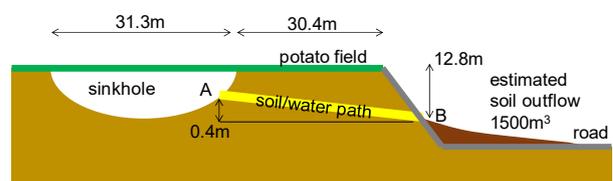
Figure 2. Cross section of the sinkhole

ground was about 30m from the sinkhole to the road. The difference of altitude between the inlet and outlet of the soil traveling path was only 0.4m. Soil with water seemed to be pushed by a large pressure. Fig. 3 shows the outlet of the soil/water path observed from the road side.

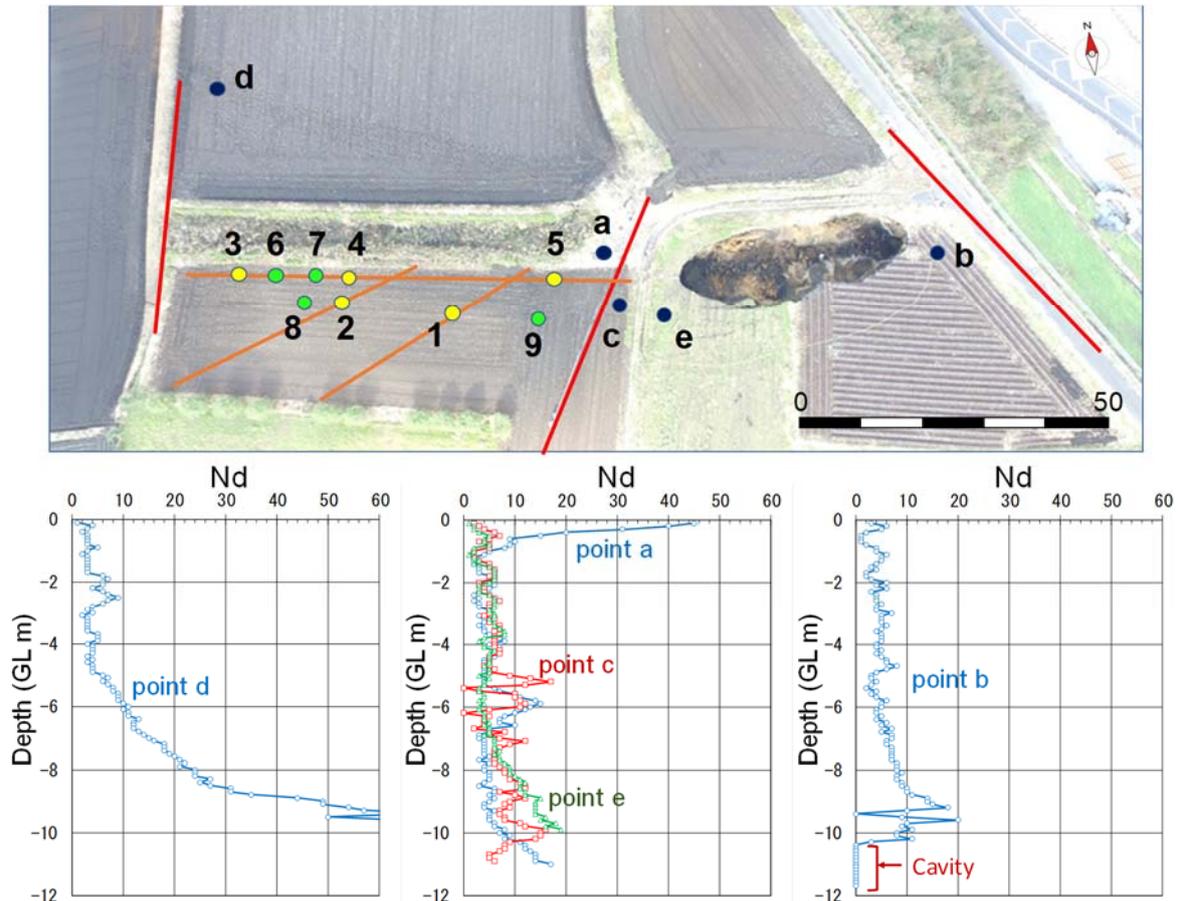
Figure 4. Measurement points for DCPT and penetration resistance, N_d , at points a to e

Dynamic cone penetration tests, DCPT, were carried at 14 points in total, a to e and 1 to 9, as indicated in Fig. 4, in which values of DCPT resistance, N_d , at points a to e are also presented. DCPTs were conducted up to 12 m deep when it was possible. At points a, b, c and e, near the sinkhole, values of N_d are around 5 up to 5 m deep. N_d values were 5 to 20 at greater depths. At point b, there was no DCPT resistance at 10 to 12 m deep. It seemed to correspond to the soil/water path of 2m high between the sinkhole and the road. At point c, at around 6m deep, the N_d values are fluctuated and no resistance was recorded twice, indicating voids in the ground. On the other hand, at point d, about 80m away from the sinkhole, N_d values increased at more than 5m deep, showing relatively stable ground condition.

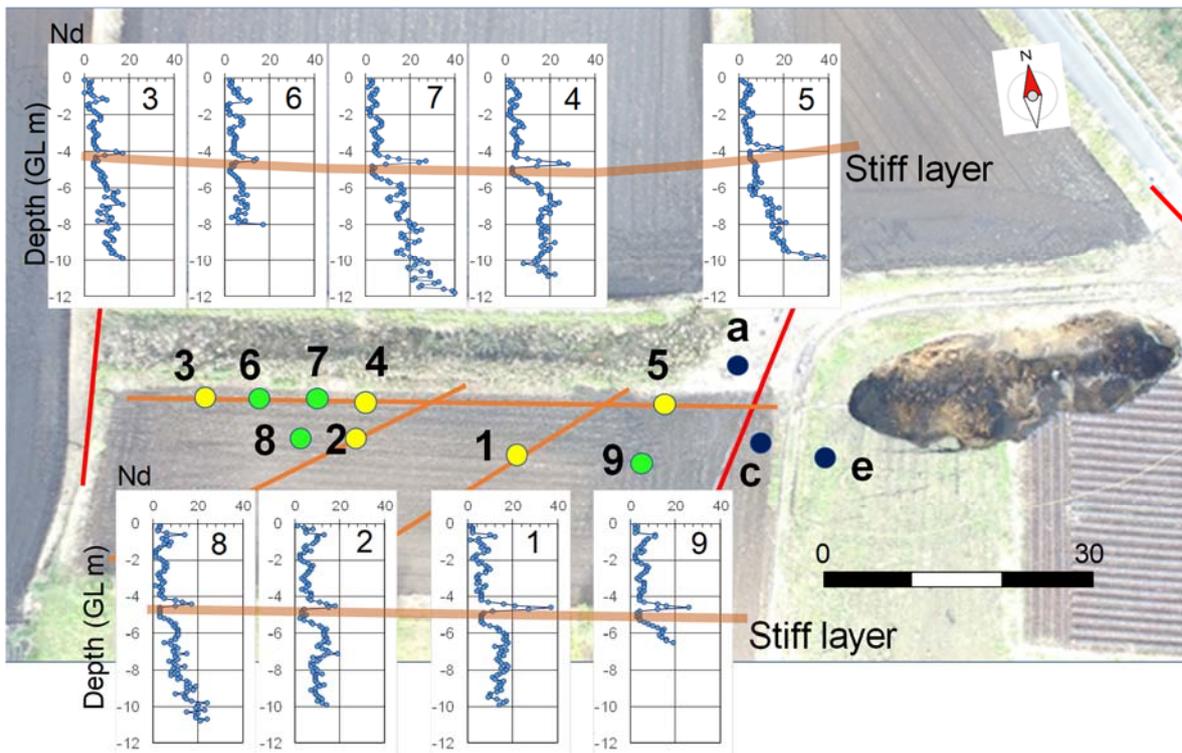
Figure 5. DCPT resistance at points 1 to 9

Fig. 5 shows N_d values for points 1 to 9. In overall, when it is deeper than 6m, the deeper the ground is, the stiffer. Particularly a stiff thin layer was found at around 4m deep for points 1 to 9, as indicated in Fig. 5, which was not observed near the sinkhole, at points a to e.

Values of elastic wave velocity and q_c showed similar trend. It was found that both wave velocity and q_c for layer 9 are notably larger, indicating stiffer and stronger soil layer. This thin stiff layer was also observed in the resistance of DCPT at point 1 to 9, as shown in Fig. 5, at around 4m deep from the surface. But it disappears at DCPT points a, c and e. It seems that the stiff layer (layer 9) gradually rising towards the sinkhole and disappear, as indicated in Fig. 10.

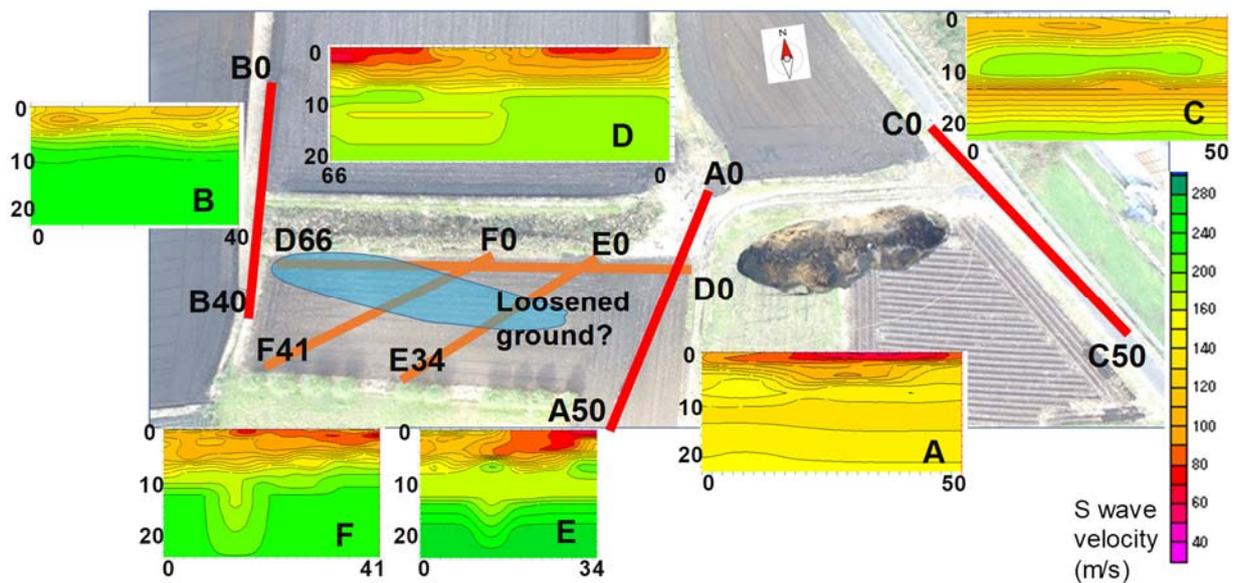
Figure 6. Surface wave survey

Surface wave survey was conducted along 6 lines, A to F. Locations of the measurement, line lengths and the results are presented in Fig. 6.

In all measurement lines, S wave velocities at less than 6m deep are slower than 120m/s. On line B, where the

least influence of the sinkhole is expected, S wave velocity deeper than 6m is greater than 200m/s. On lines A and C, near the sinkhole, S wave velocities indicated the presence of loosened ground up to 10 to 15m. But in line C, the soil/water path in the ground could not be identified by the surface wave survey. In lines D, E and F, the results implied that there is a loosened area at around 10m deep.

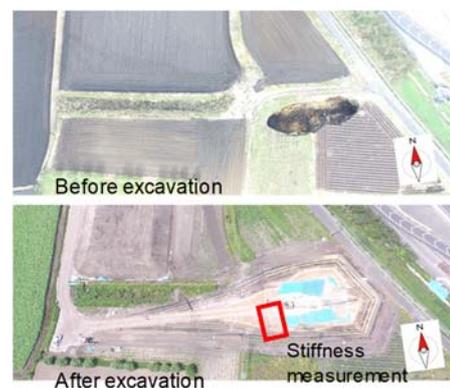
Figure 7. Around the sinkhole before and after excavation

On the occasion of repair work of the sinkhole, the excavation was carried out around it. Fig. 7 shows photos before and after the excavation. Soil strata was exposed

and the evaluation of stiffness of each soil layer by the measurement of elastic wave velocity and cone penetration resistance, q_c , became possible, as shown in Fig. 8. Values of q_c were obtained using a portable cone penetrator. The location of the measurement is indicated in Fig. 7. Fig. 9 shows soil layers, cone penetration resistances and elastic wave velocities of each layer.

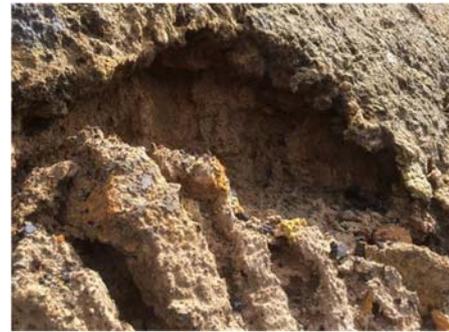
Figure 11. Loose volcanic sand which was erodible easily by rain

Very loose and erodible volcanic sand layer 10 spreads below the stiff layer 9. When it was exposed, it was easily eroded by the rain, as shown in Fig. 11. At the location of the sinkhole, an impermeable clay layer lies below the loose volcanic sand.

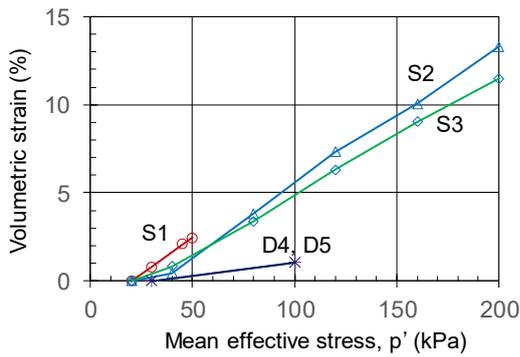
Figure 12. Volumetric strains during isotropic consolidation

Three undisturbed samples were isotropically consolidated up to 50 kPa for S1, and 200 kPa for S2 and S2, respectively. Volumetric strains developed during isotropic compression are shown in Fig. 12, in which volumetric strains of non-plastic silt compacted as loose as possible state, D4 and D5, was also shown. Volumetric strains of Shirasu was significantly larger than loose non-plastic silt.

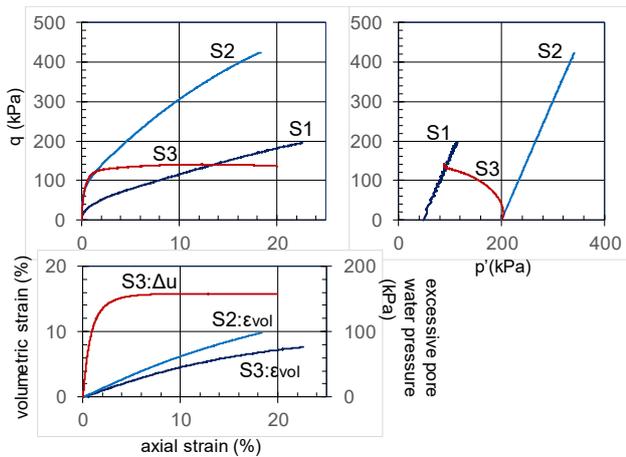
Figure 13. Drained and undrained triaxial compression for Shirasu

S1 and S2 were sheared in the drained condition, while undrained compression was conducted for S3. Fig. 13 presents stress-strain relationships, volumetric strains, excessive pore water pressures, and effective stress paths. All three specimens showed strong contractancy. Samples seemed to have capacity for further contraction in the drained condition even at around 20% of axial strain. The shape of S2 specimen after the test is presented in Fig. 14. The specimen kept cylindrical shape and no lateral bulging was observed. Fine content of S1 and S2 after the test was 31% and 38% respectively. Compared to the initial fine content of 28%, increase in fine content indicated the effect of particle crushing. In undrained triaxial compression, shearing continued after the stress

point reached constant p' and constant q at an axial strain of 2%. It implies the soil has a potential for flow failure when it is subjected to rapid loading.

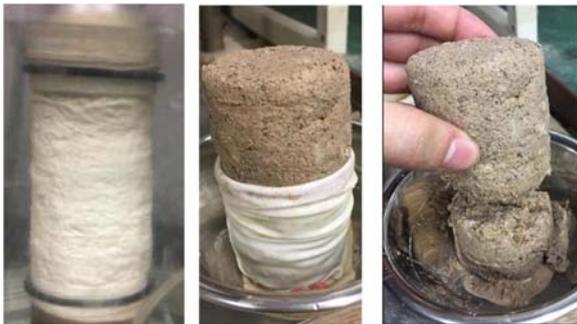
Figure 14. Shape of S2 specimen after CD test (confining pressure:200kPa, sheared up to axial strain of 20%)

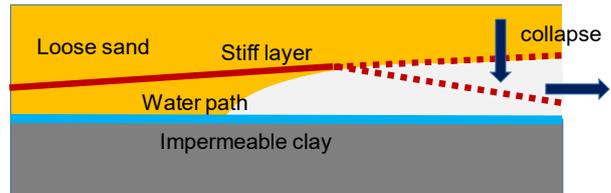
Figure 15. Estimated mechanism of sinkhole formation

It is likely that a water path was formed on the boundary between clay and sand layer, due to contact erosion. Loose sand became even looser and weaker due to internal erosion. Voids or cavities may be developed. The water path seemed to be about 100m long at around 12m deep. The thin stiff layer at 4m deep may act as a kind of roof on the voids but it disappears at the location of the sinkhole. Due to very heavy rain brought by typhoon, internal erosion was accelerated. The cover soil on the water path could not sustain and collapsed as schematically illustrated in Fig. 15. Judging from elongated shape of the sinkhole, two or three sinkholes simultaneously or successively occurred above the water paths.

Results of investigation implied the presence of water path of about 100m lying at the depth of 12m, at the boundary of impermeable clay and loosely deposited volcanic sand. This possibly caused internal erosion and created voids and cavities in sand. A thin stiff layer at 4m deep may have helped to support the soil above cavities but when the cavity grew and expanded due to heavy rain, it could not sustain and finally collapsed. Considering very high compressibility and crushability of volcanic sand, it was probably liquefied at the moment of collapse. However, it is still surprising that such large amount of soil splashed out through a narrow gap of 30m distance.
