Several cases of backward erosion/liquefaction piping from Hungary

BSTRACT: Some cases of backward erosion/liquefaction piping are described. These distinguish between usual sand boils and the ‘fast’ piping, the - possibly dynamic liquefaction induced – breach. The latter happens in a matter of minutes, whereas in the former emergency response measures can be effective.

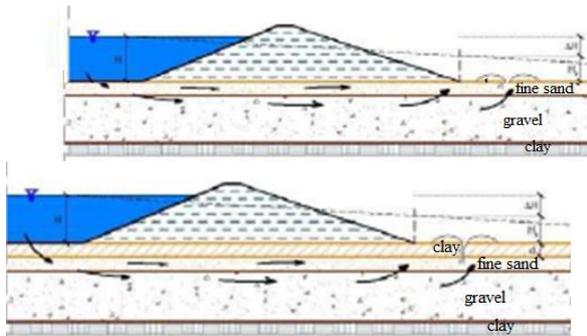
Figure 2. Layers leading to sandboils.

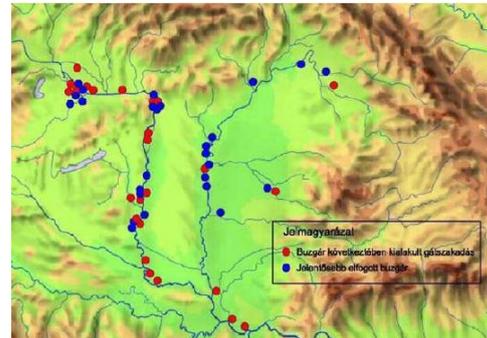
Figure 4. The big rivers and piping failures (red) and defended sand boils (blue) in Charpatian basin [6], [10] Nagy, 2014.
