# The importance of investing in site characterization in a dam project to avoid impending losses

**ABSTRACT:** In dam design, site characterization, aside of providing engineering property values, should be able to capture the variability and complexity of geotechnical, engineering geology, hydrogeology conditions in the dam sites. This information plays critical role as it frequently becomes a basis in selecting different scenarios in the design. This paper presents a case study of a rockfill dam construction in Indonesia highlighting the importance of site characterization in reducing uncertainties. In the early construction stage, additional field investigation was performed and identified the presence of high-porosity confined aquifer layer below dam foundation. This finding urged that the initial design of grouting curtain wall could no longer be applied. Dam redesigning required considerable effort and resulted in time and financial losses. Investing in site characterization is believed to reduce uncertainties that eventually avoiding any imminent negative consequences.

**Keywords:** rockfill dam design; grout curtain; secant pile; site characterization

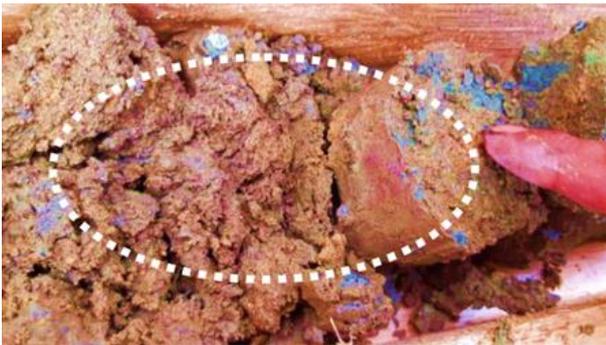
Figure 3. Phenolphthalein traces

In this project, trial grouting test was performed prior to grout curtain installation along dam as, in location T1, T2, and T3 (Fig. 2). Trial tests in T1 and T2 were conducted up to depth of 40 m. The trial borehole spacing for T1 and T2 are 3 m and 2 m, respectively. Testing in T3 was conducted up to depth of 20 m with borehole spacing of 1 m. Test result in T1 indicated a mediocre grouting effectivity, with average value of 45.98%. In T2, the trial result also indicated a mediocre grouting effectivity as well. Nevertheless, high grouting effectivity was shown at depth of 20 – 25 m having a very Lugeon value of 0.43. Trial test in T3 showed good grouting effectivity with significantly lower Lugeon value. Nevertheless, coring using phenolphthalein 0.1n did not show grout cement trace. In T3 location, 2 other boreholes were made to form a 0.3 m-spacing triangular pattern with an initial borehole. For this spacing, grouting effectivity reached  $> 80\%$ . A 0.1n phenolphthalein test on the core also showed the presence of grout cement (Fig. 3).
